Chance Oil and Gas, Eagle Plains Project: Linear Feature Study

EDI Project

22Y0505
May 2023

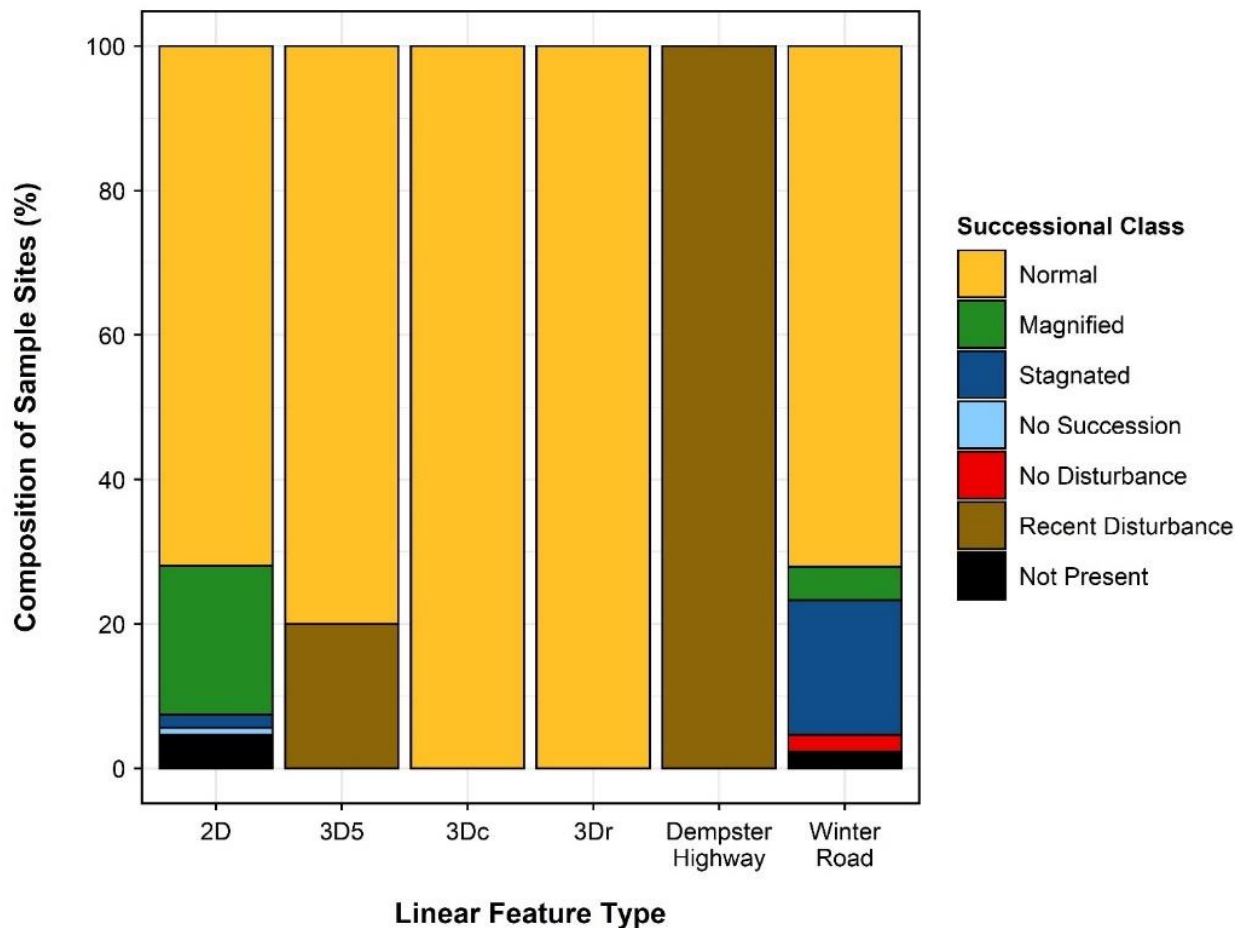
Figure 4-1. Summary of successional classes observed across different linear feature types in the Eagle Plains RSA.

Linear features surveys in the Eagle Plains RSA observed five of the six of the successional classes documented by Simpson (2008): normal succession, magnified succession, stagnated succession, no succession, and recent disturbance (Figure 4-1) (Attachment A). No retrogressive succession sites were observed at official survey sites. However, a small number of retrogressive sites were incidentally observed on winter roads while travelling through the RSA.

Most sites surveyed (79%) were undergoing normal succession. The next most common successional class was magnified succession, occurring in 11% of sites, followed by stagnated succession, occurring in 5% of sites. All 3D seismic lines surveyed followed a normal successional trajectory, except for one site that was classed as recently disturbed. Magnified succession was most common in 2D seismic lines (21%), while stagnated succession was most common in winter roads (19%). Successional classes were defined as ‘not present’ if the linear feature was not present in the field or had regenerated to a stage that was not discernable from the adjacent areas. The Dempster Highway was classified as recently disturbed due to the regular maintenance of the road.

Fire history appeared to influence some successional classes. Magnified succession was more common at burnt sites (19 burnt versus 5 unburnt). In contrast, stagnated succession was more common at unburnt sites (3 burnt versus 7 unburnt). Sites on a normal successional trajectory did not appear to have any relationship to burnt status. The remaining successional classes were too uncommon to draw any conclusions.

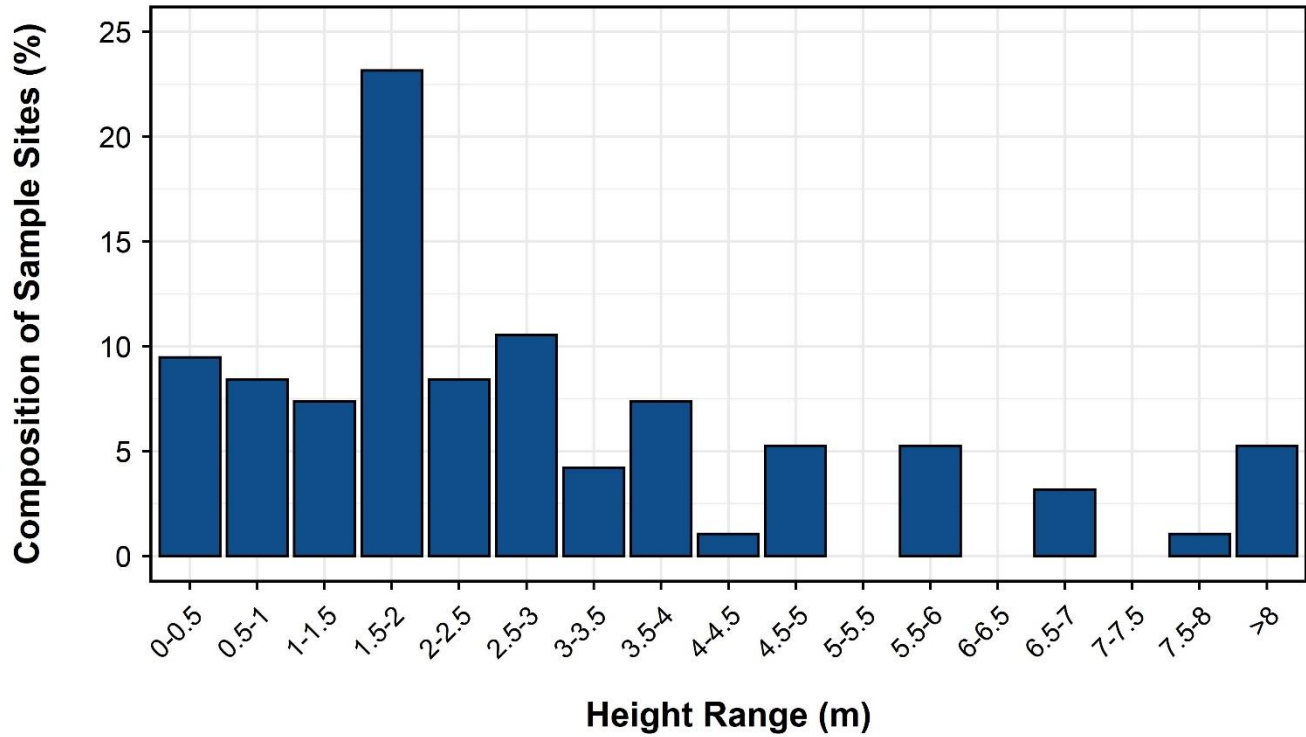
Figure 4-4. Vegetation height distribution of on-line 2D and winter road plots in the Eagle Plains RSA.

In comparison, recovering 2D seismic lines and winter roads shared a relatively uniform distribution between 0 m and 4 m but with a peak occurring at vegetation heights measuring 1.5–2 m tall (Figure 4-4). Only 21% of 2D and winter roads contained dominant vegetation ≥ 4 m, and only 5% were ≥ 8 m tall. 3D seismic lines were rarely composed of vegetation ≥ 2 m, and most of the vegetation (67%) recovering on 3D lines was less than 1 m (Figure 4-5). This is very different from the off-line undisturbed height distribution. However, 3D lines were all only five years old at sampling, and shorter vegetation was expected.

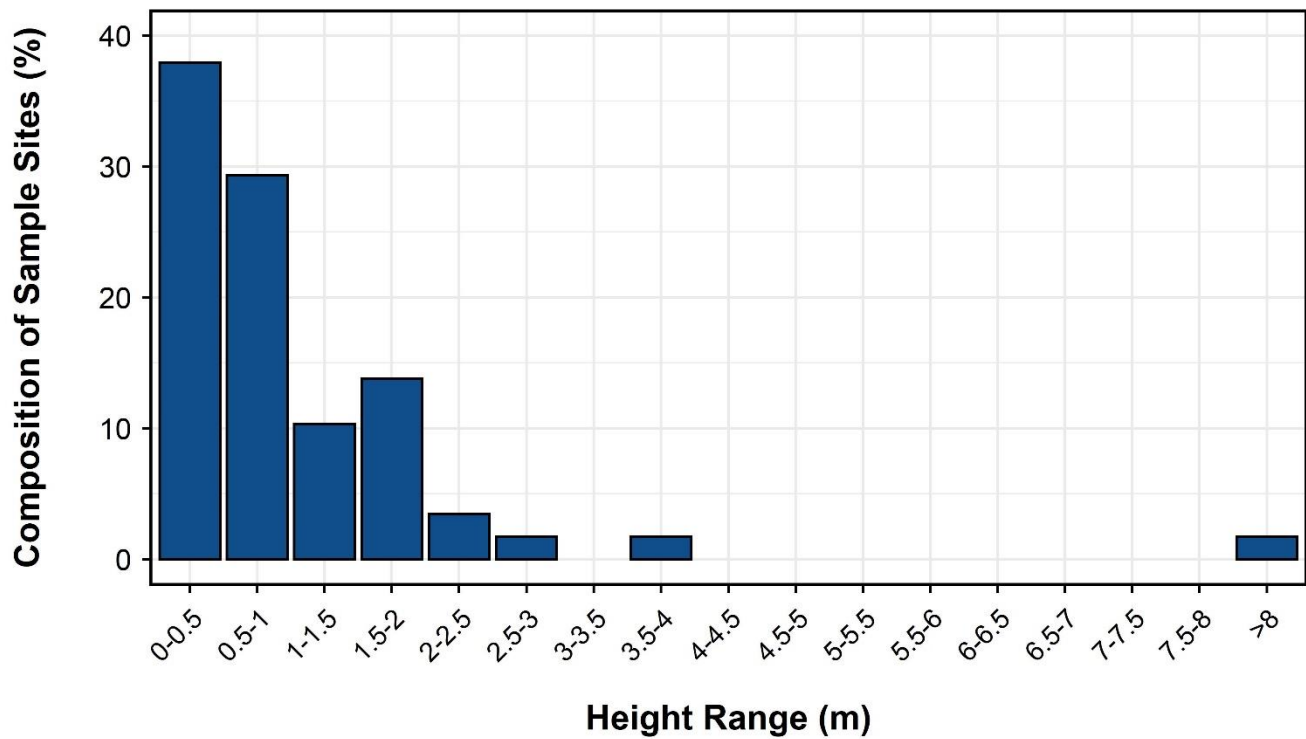
Figure 4-5. Vegetation height distribution of on-line 3D plots in the Eagle Plains RSA.

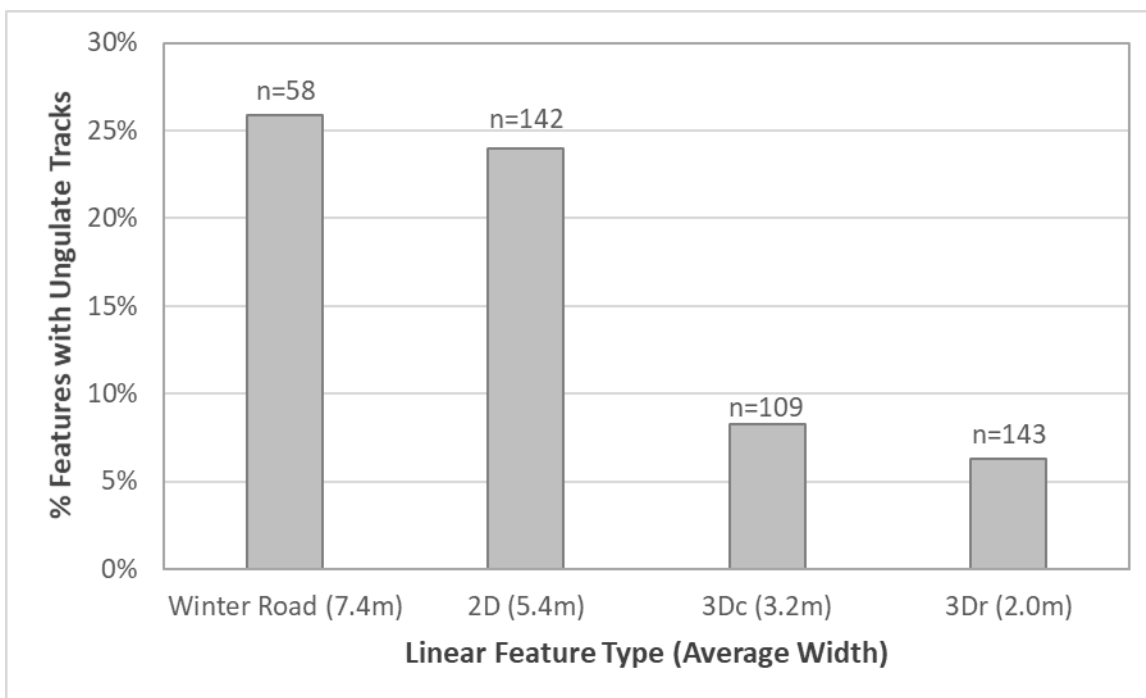
Figure 4-6. Relative use of different linear feature types by ungulates in the Eagle Plains RSA, March 2020.
The numbers above bars indicate the number of features surveyed.

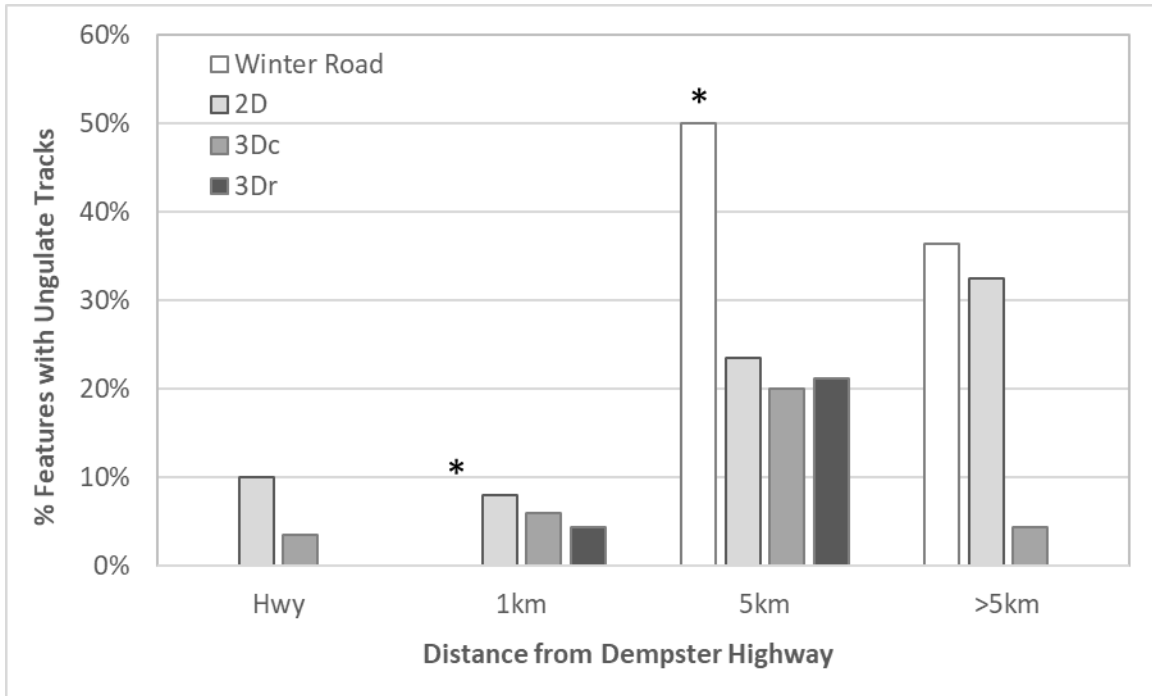
Figure 4-7. Relative use of different linear feature types by ungulates in relation to distance from the Dempster Highway in the Eagle Plains RSA, March 2020.

*The * indicates bars with small samples sizes (n=5-10); all other instances have at least 10 data points per feature type within each distance class*

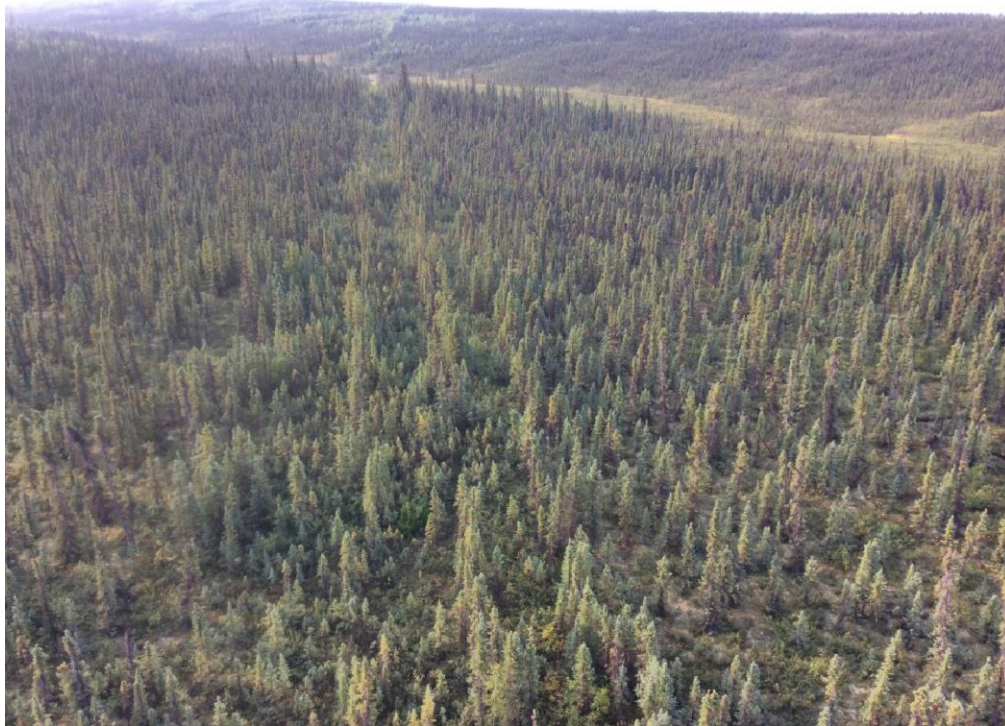
Attachment Photo A-1. Air survey plot SL237, an unburnt 2D seismic line undergoing normal succession at a young forest structural stage when surveyed.

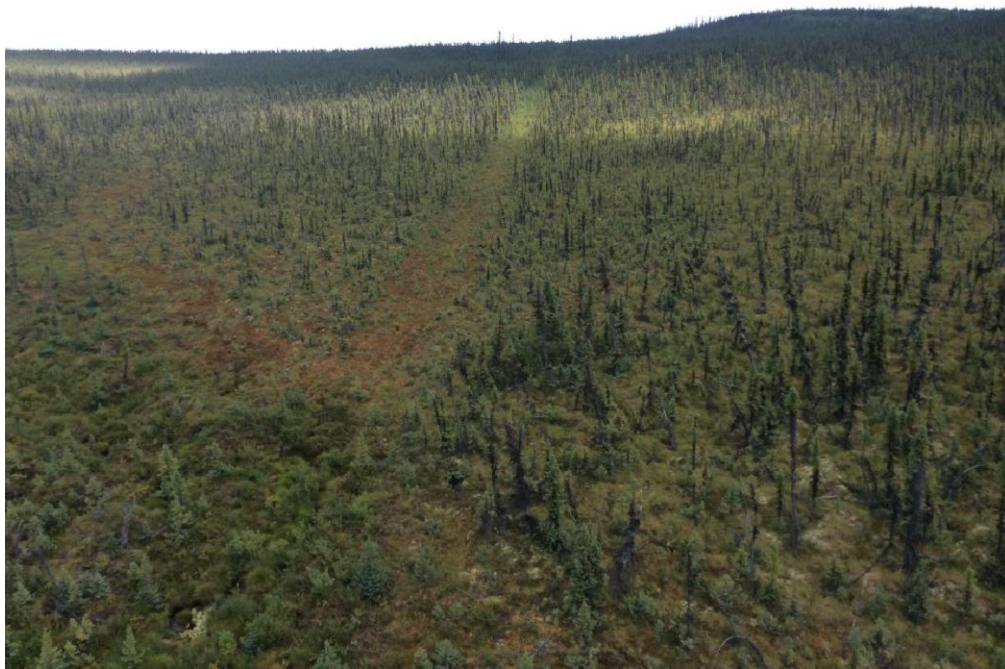
Attachment Photo A-2. Air survey plot SL269, an unburnt 2D seismic line undergoing normal succession at a low shrub structural stage when surveyed.

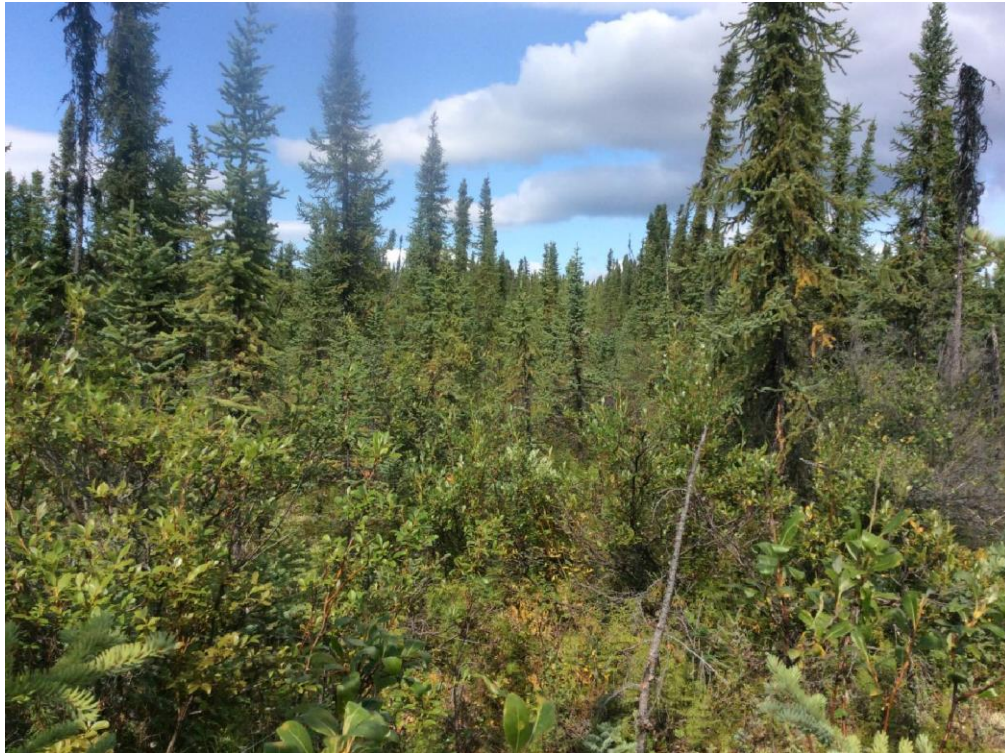
Attachment Photo A-3. Ground survey plot SL310, an unburnt 2D seismic line undergoing normal succession at a tall shrub structural stage when surveyed.

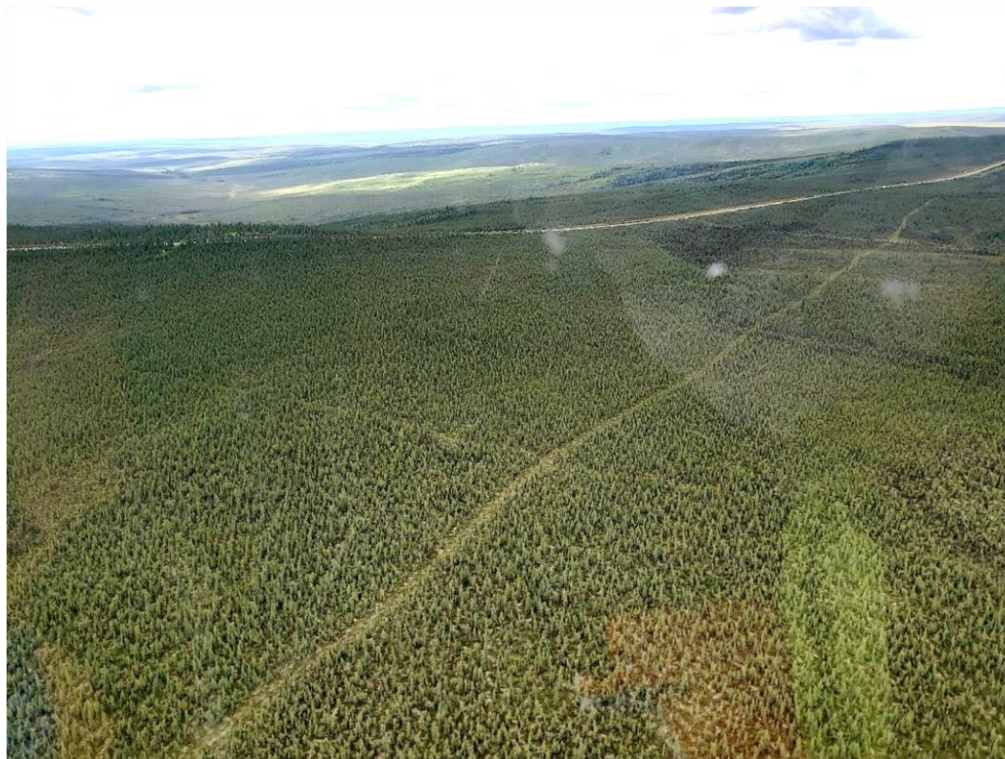
Attachment Photo A-4. Aerial view of 3D seismic lines undergoing normal succession – meandering routes were used to mitigate some functional disturbance impacts.

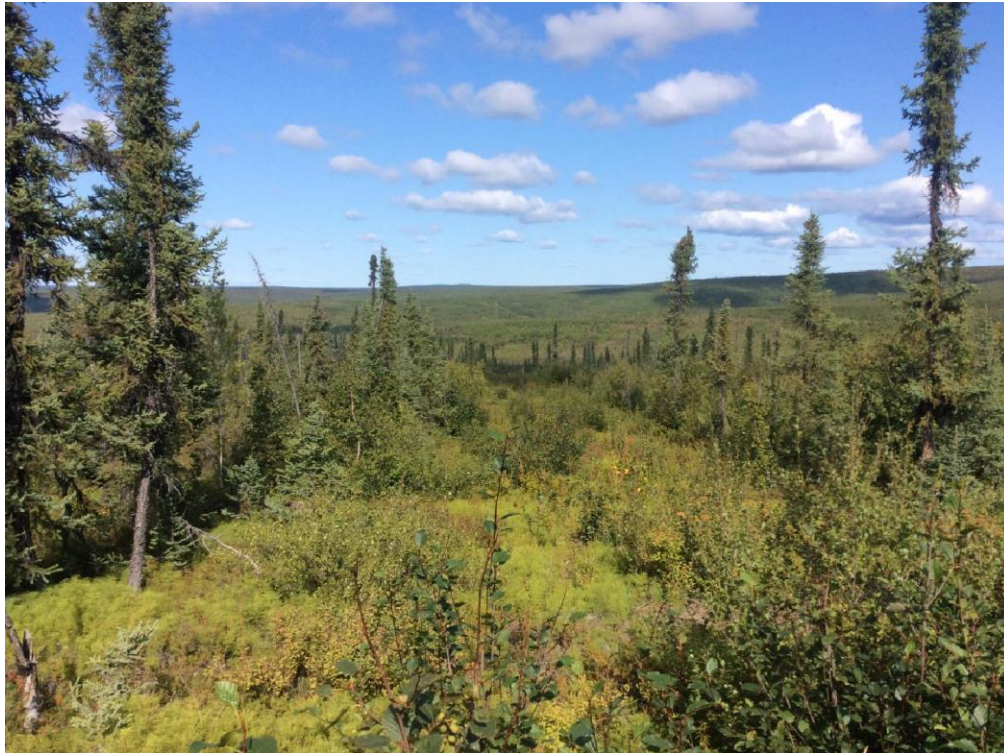
Attachment Photo A-5. Ground survey plot SL357, a burnt 3D5 seismic line undergoing normal succession at a low shrub structural stage when surveyed.

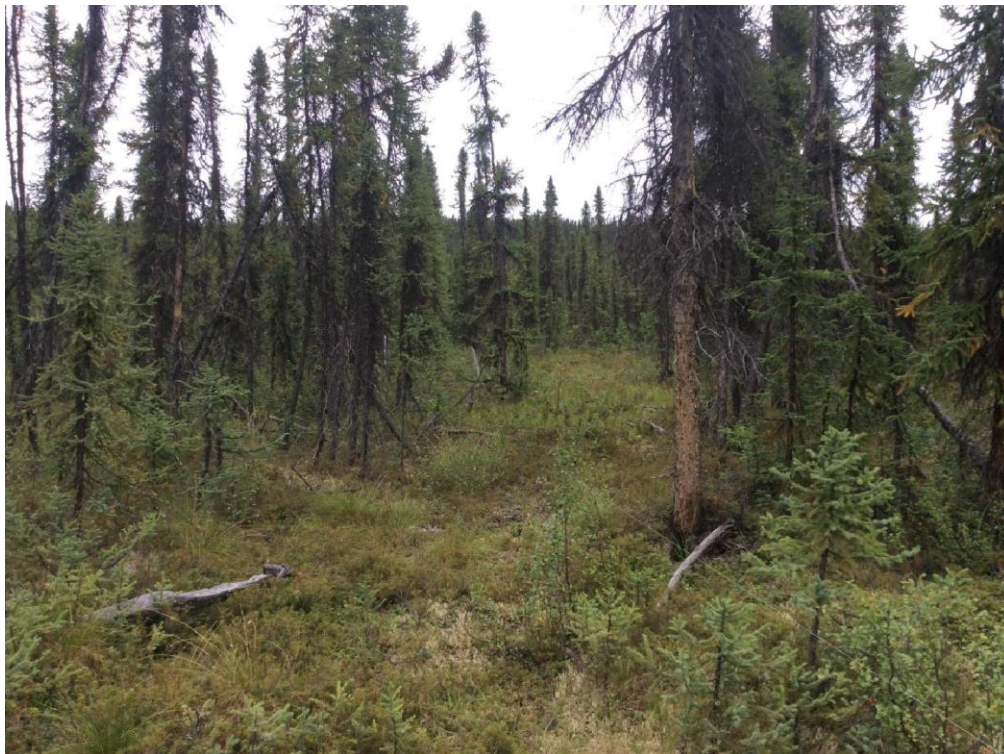
Attachment Photo A-6. Ground survey plot SL277, an unburnt 3Dc seismic line undergoing normal succession at a low shrub structural stage when surveyed.

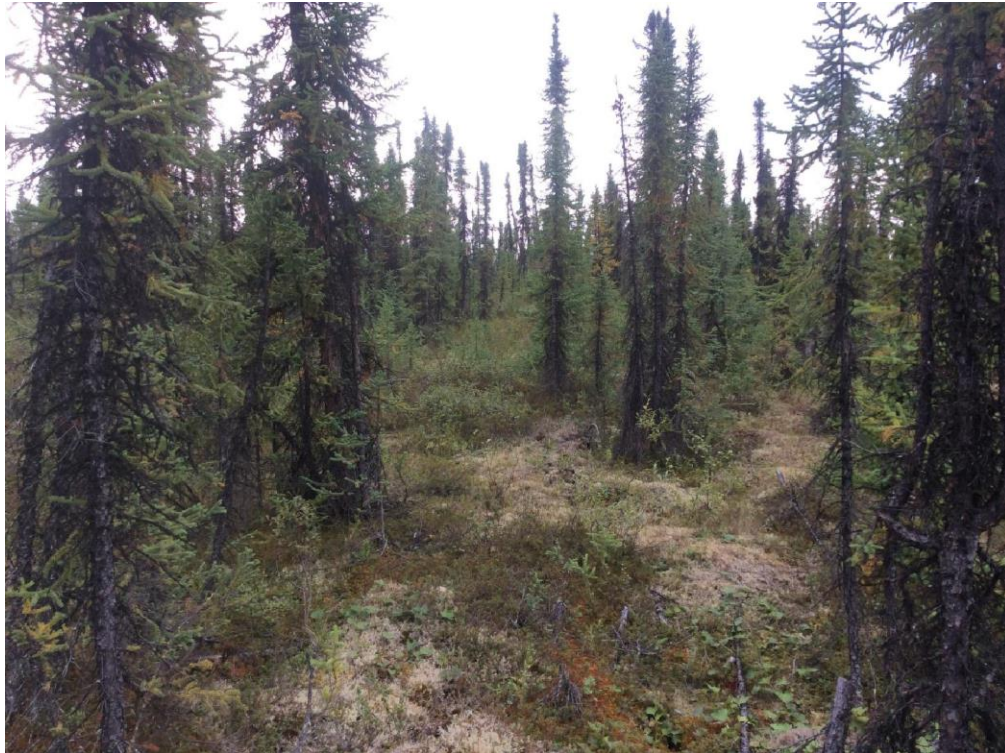
Attachment Photo A-7. Ground survey plot SL255, an unburnt 3Dr seismic line undergoing normal succession at a low shrub structural stage when surveyed.

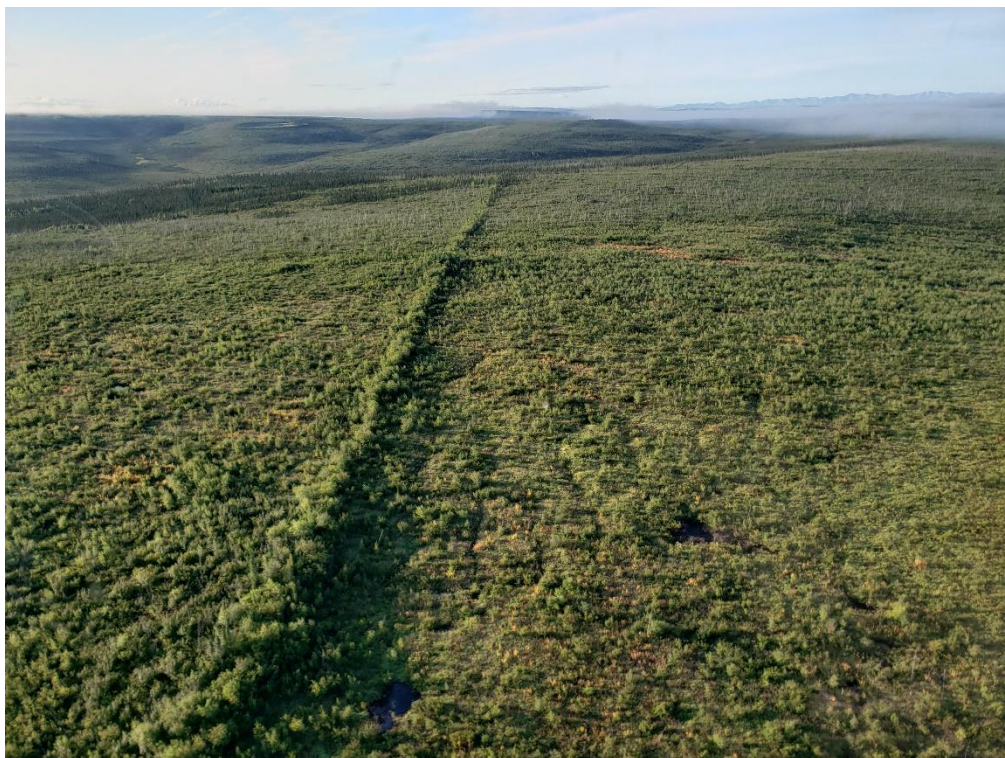
Attachment Photo A-8. Aerial view of a burnt 2D seismic line undergoing magnified succession at a tall shrub structural stage when observed.

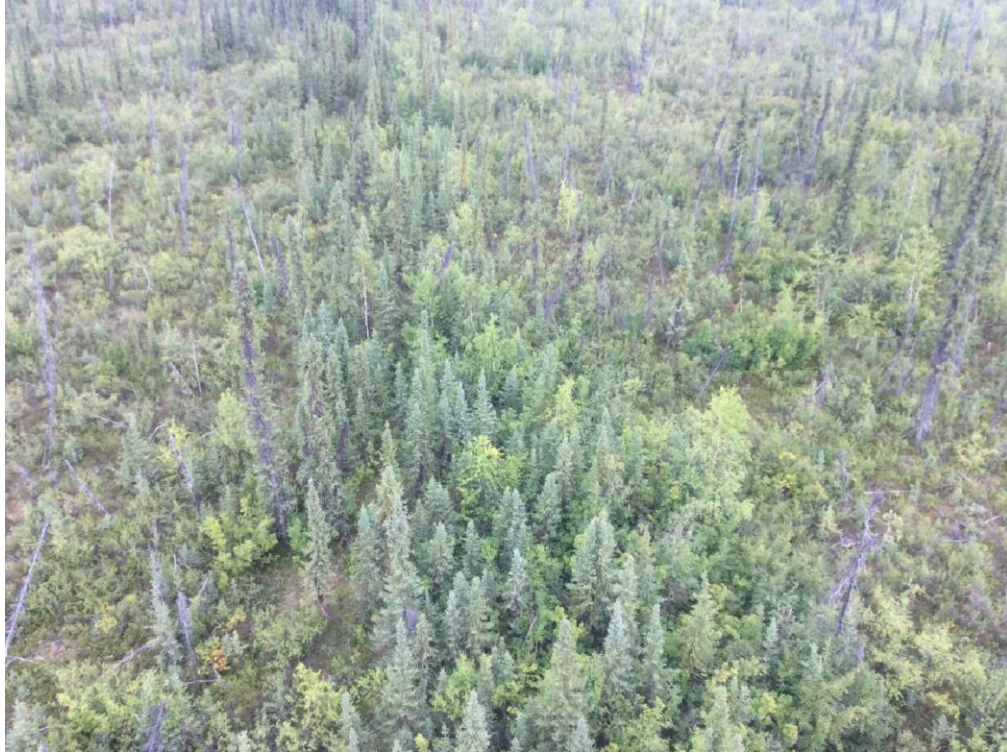
Attachment Photo A-9. Air survey plot SL234, an unburnt winter road undergoing magnified succession at a sapling forest structural stage when surveyed.

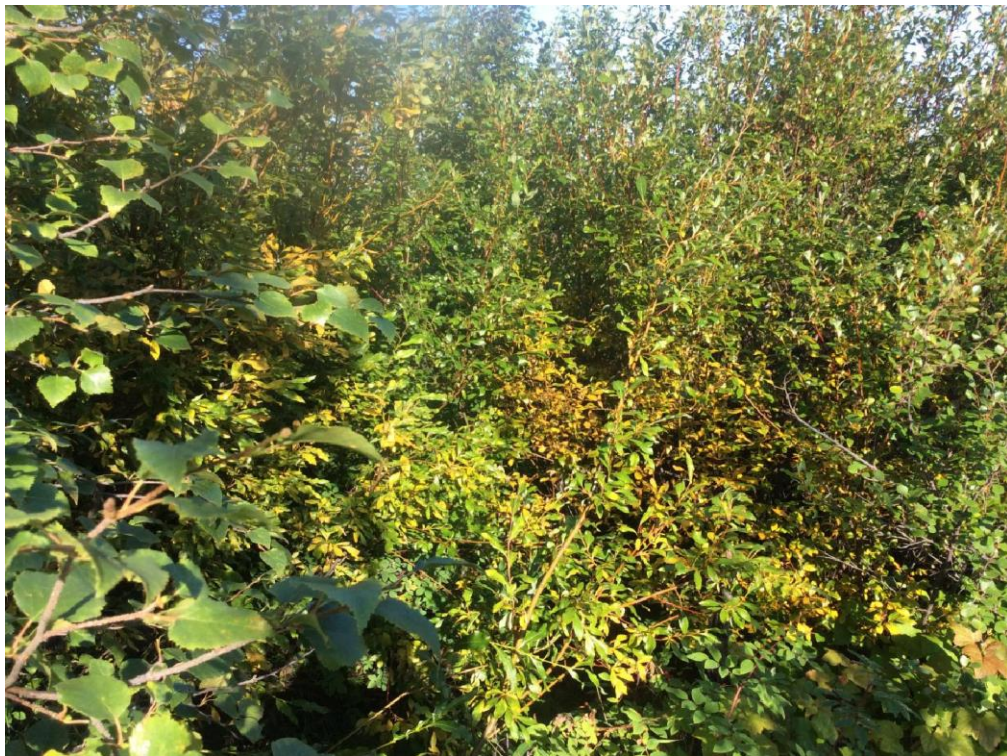
Attachment Photo A-10. Ground survey plot SL317, a burnt 2D seismic line undergoing magnified succession at a tall shrub structural stage when surveyed.

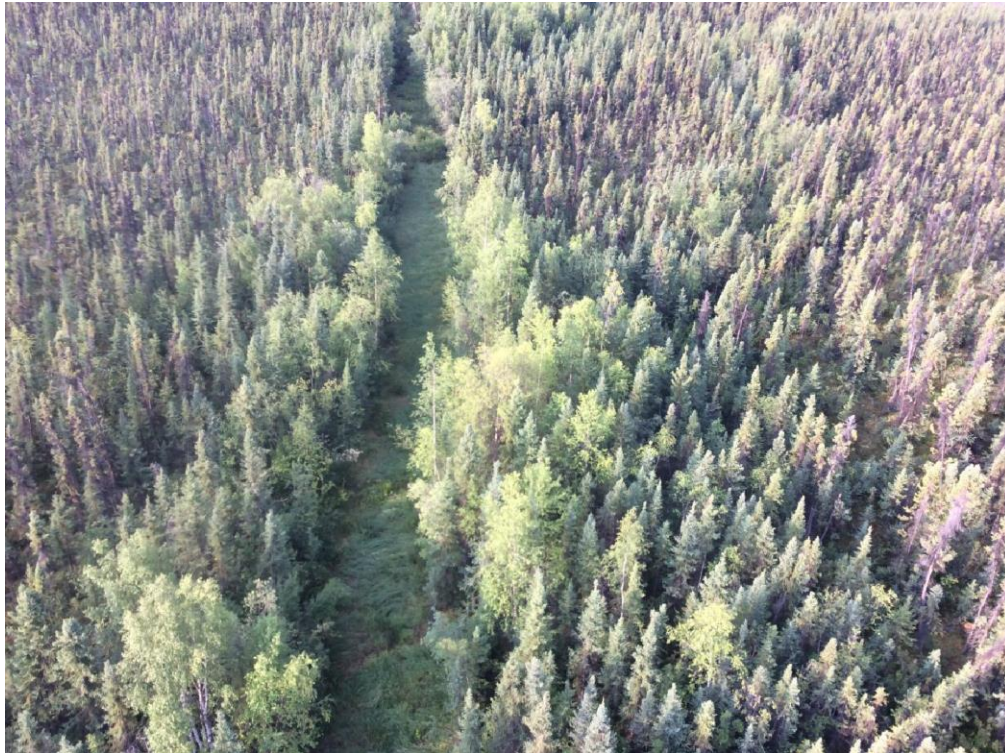
Attachment Photo A-11. Air survey plot SL238, an unburnt winter road undergoing stagnated succession at a forb-dominated herb structural stage when surveyed.

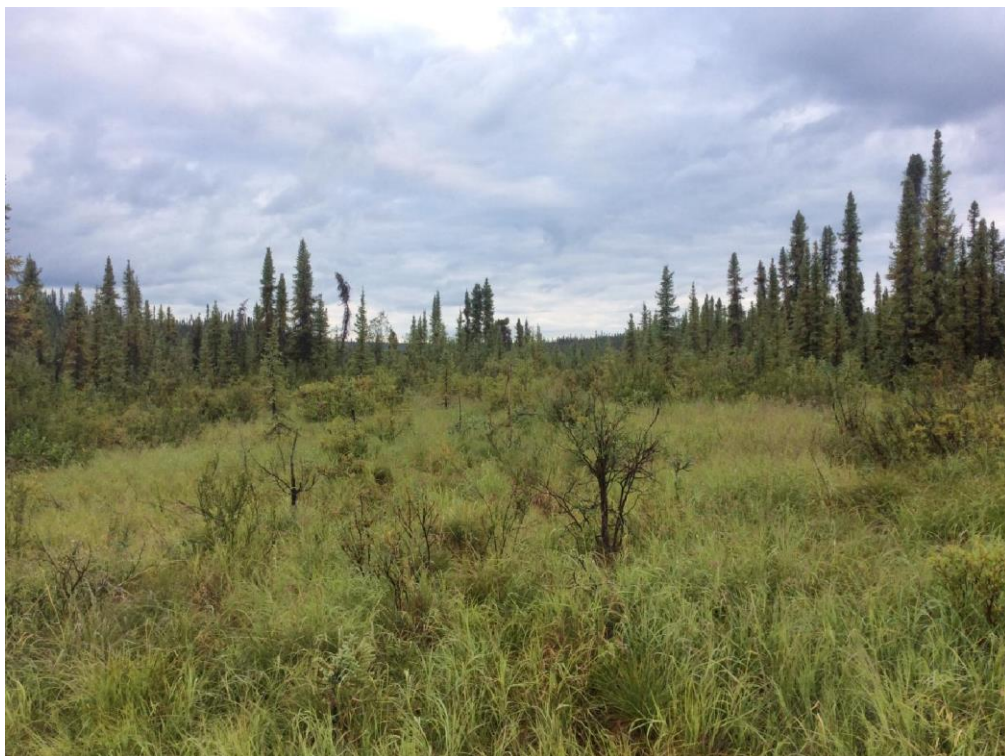
Attachment Photo A-12. Ground survey plot SL264, an unburnt winter road undergoing stagnated succession at a graminoid-dominated herb structural stage when surveyed.

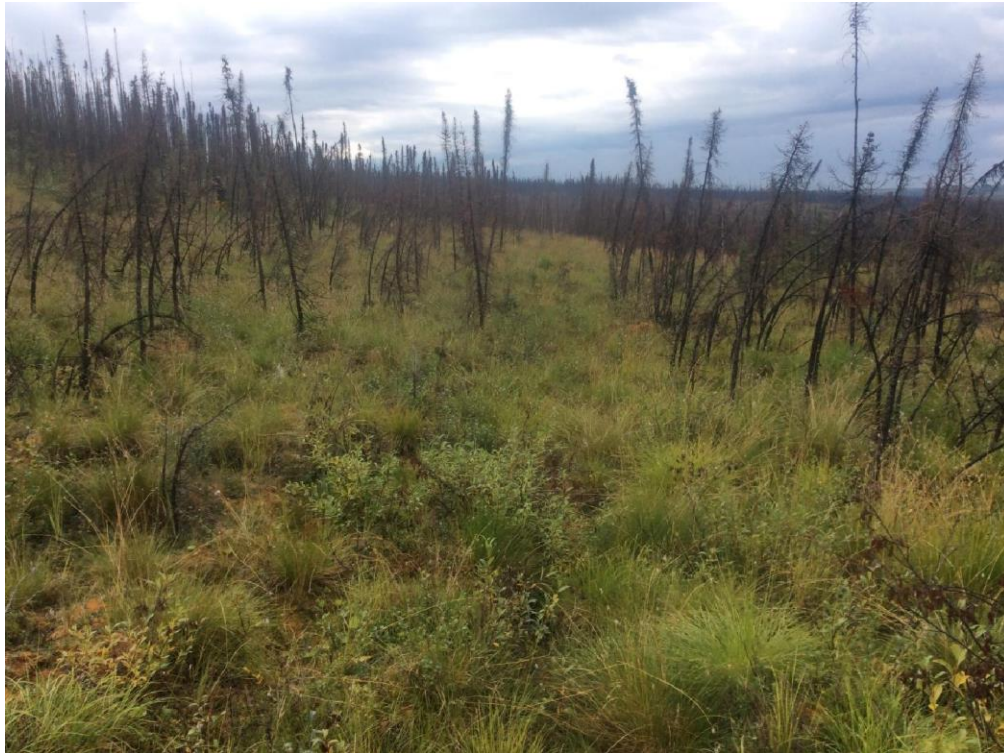
Attachment Photo A-13. Ground survey plot SL226, a burnt 2D seismic line undergoing normal succession at a forb-dominated herb structural stage when surveyed.

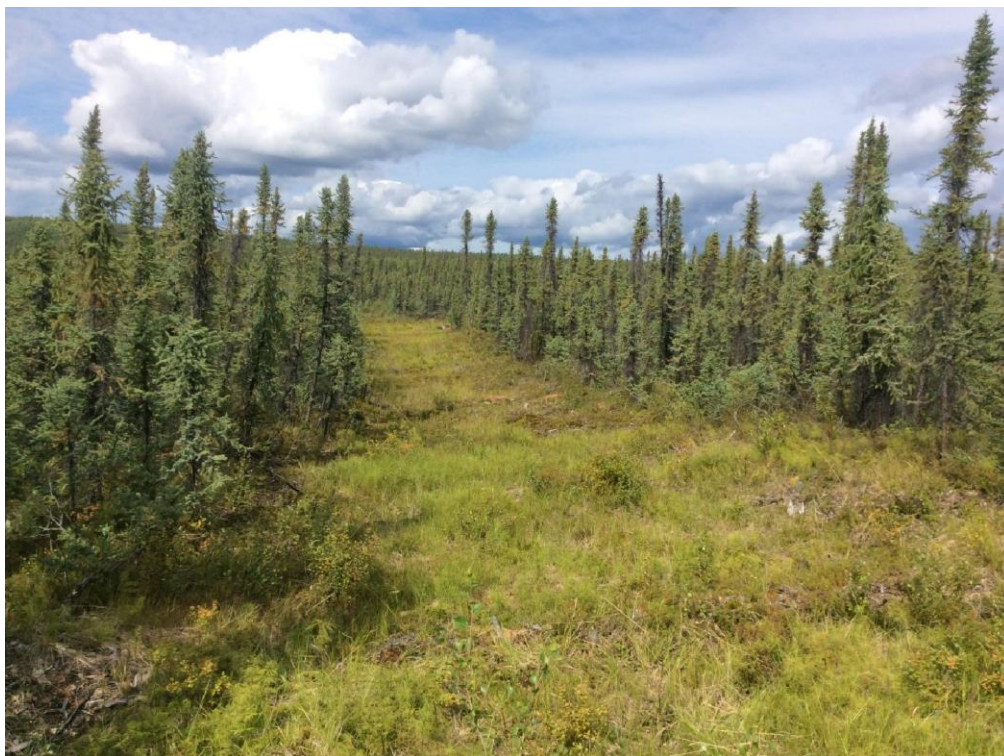
Attachment Photo A-14. Ground survey plot SL329, an unburnt 3D5 seismic line classified as recent disturbance at a forb-dominated herb structural stage when surveyed.

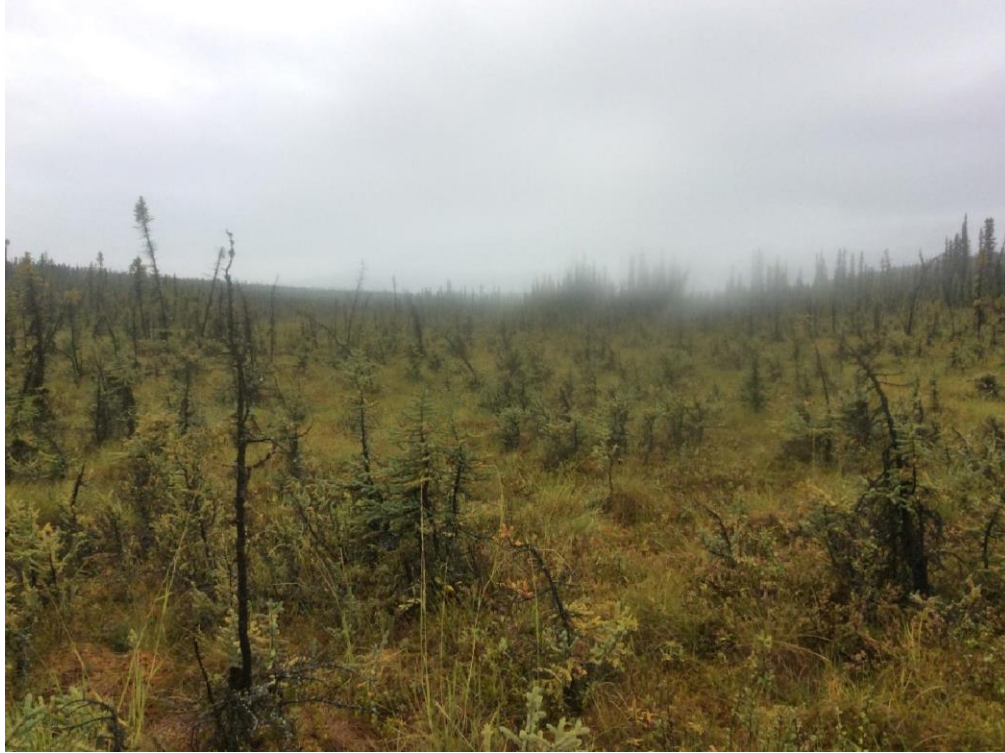
Attachment Photo A-15. Ground survey plot SL338, an unburnt, undisturbed reference plot at a low shrub structural stage when surveyed.

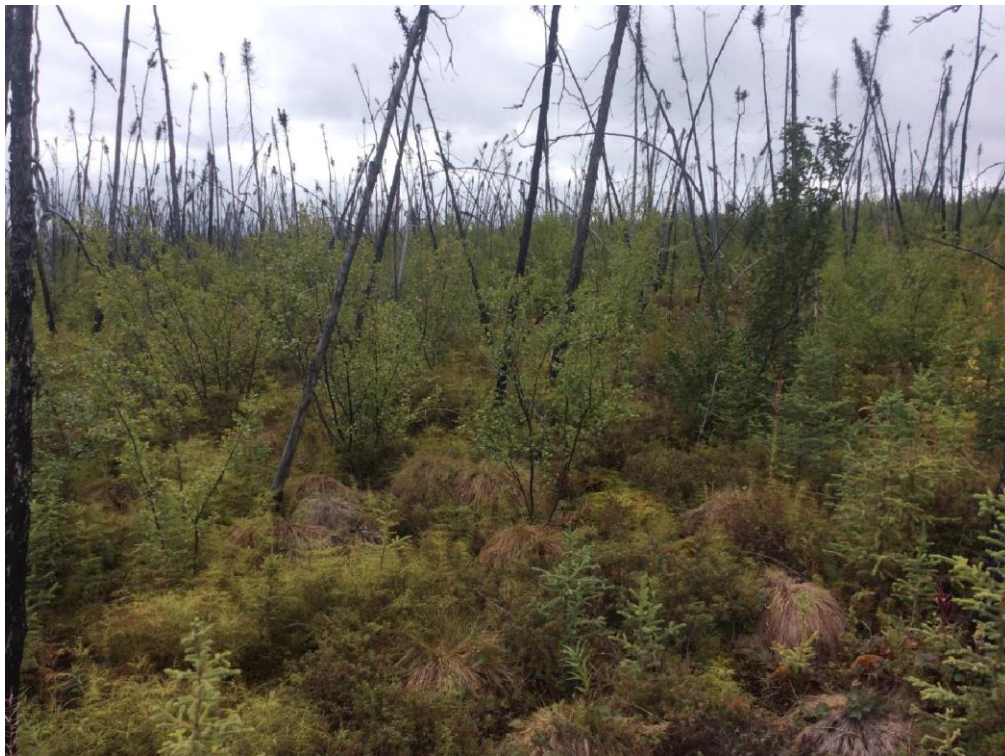
Attachment Photo A-16. Ground survey plot SL350, a burnt undisturbed reference plot at a low shrub structural stage when surveyed.

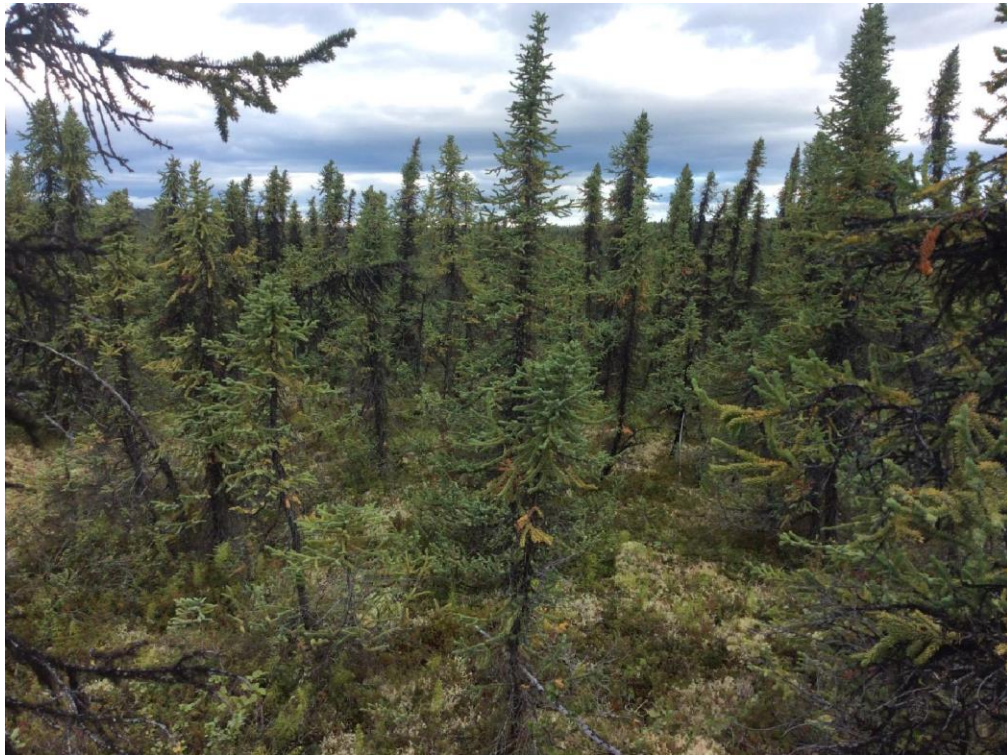
Attachment Photo A-17. Ground survey plot SL304, an unburnt undisturbed reference plot at a tall shrub structural stage when surveyed.

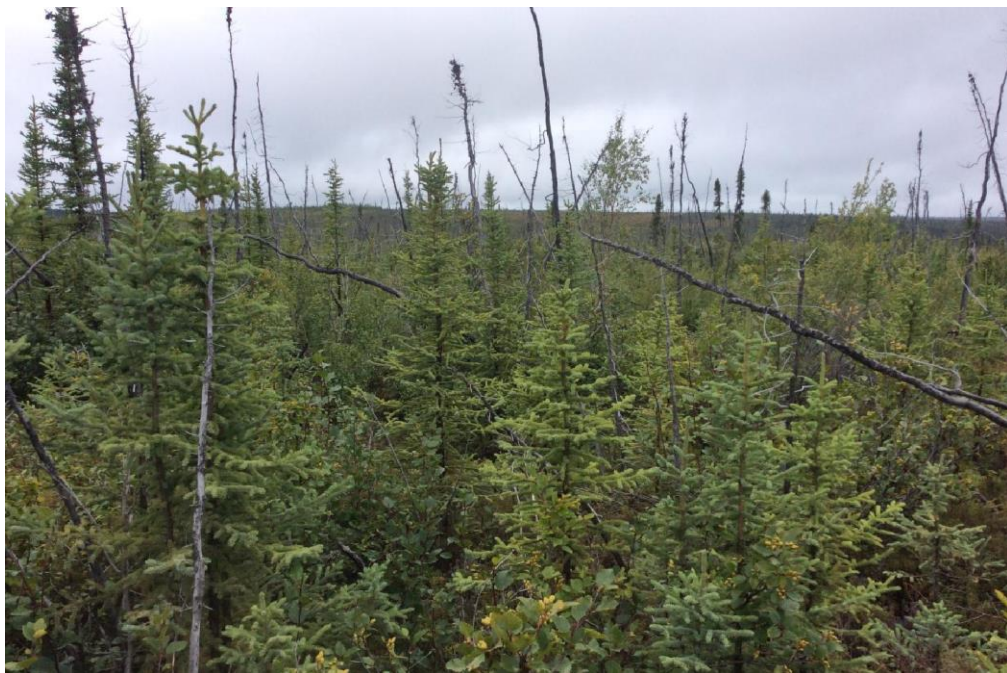
Attachment Photo A-18. Ground survey plot SL346, a burnt undisturbed reference plot at a tall shrub structural stage when surveyed.

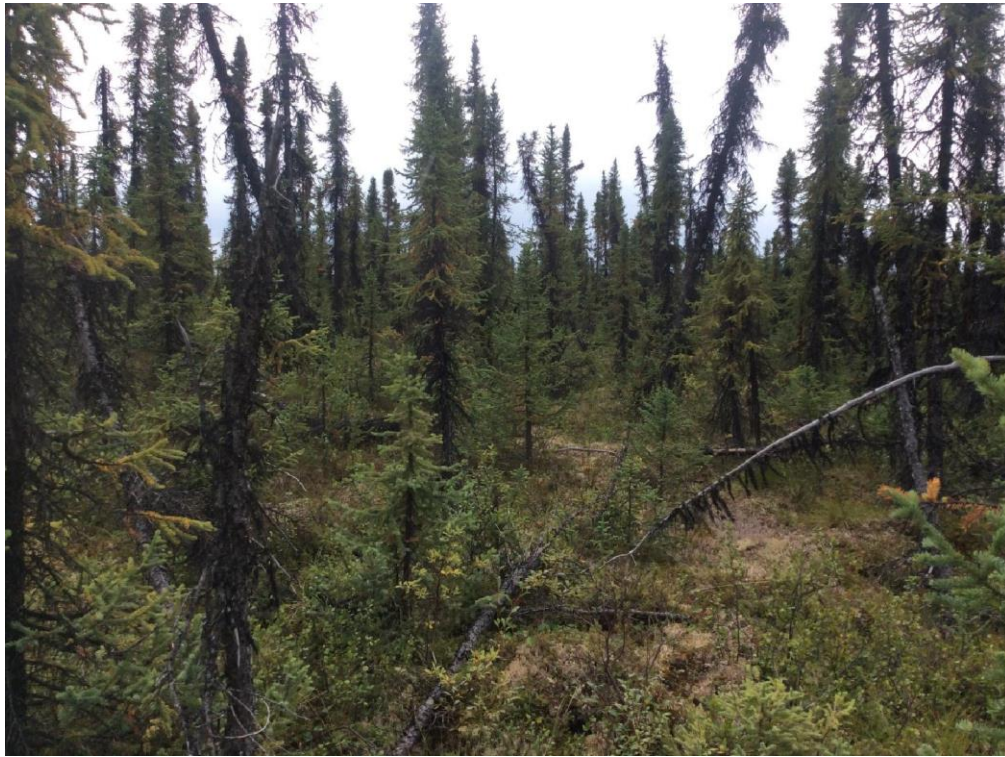
Attachment Photo A-19. Ground survey plot SL3260, an unburnt undisturbed reference plot at a mature forest structural stage when surveyed.

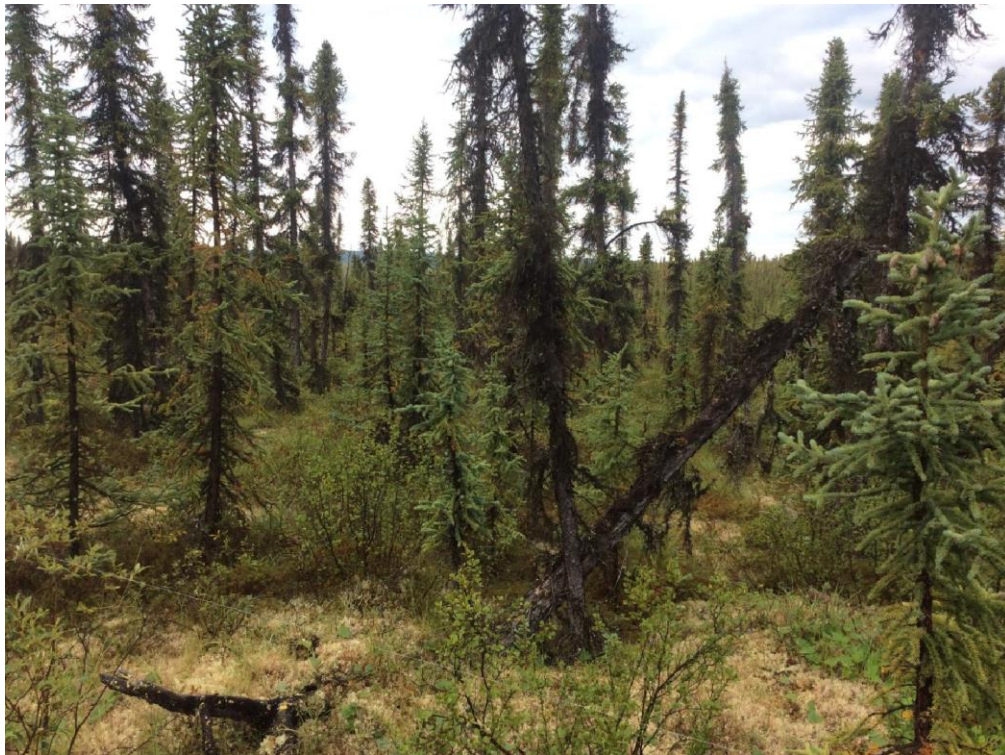
Attachment Photo A-20. Ground survey plot SL264, an unburnt undisturbed reference plot at an old forest structural stage when surveyed.

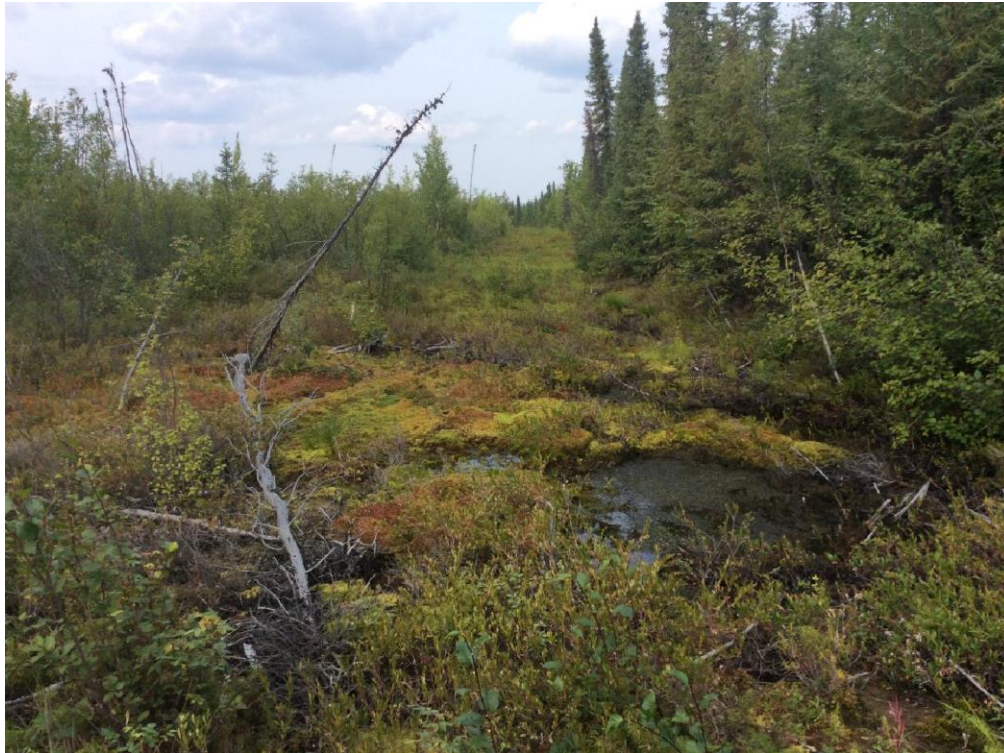
Attachment Photo A-21. Ground survey plot SL243, a burnt winter road with melt pockets present, indicating permafrost degradation.
