Chance Oil and Gas, Eagle Plains Project: Linear Feature Study

EDI Project

22Y0505
May 2023

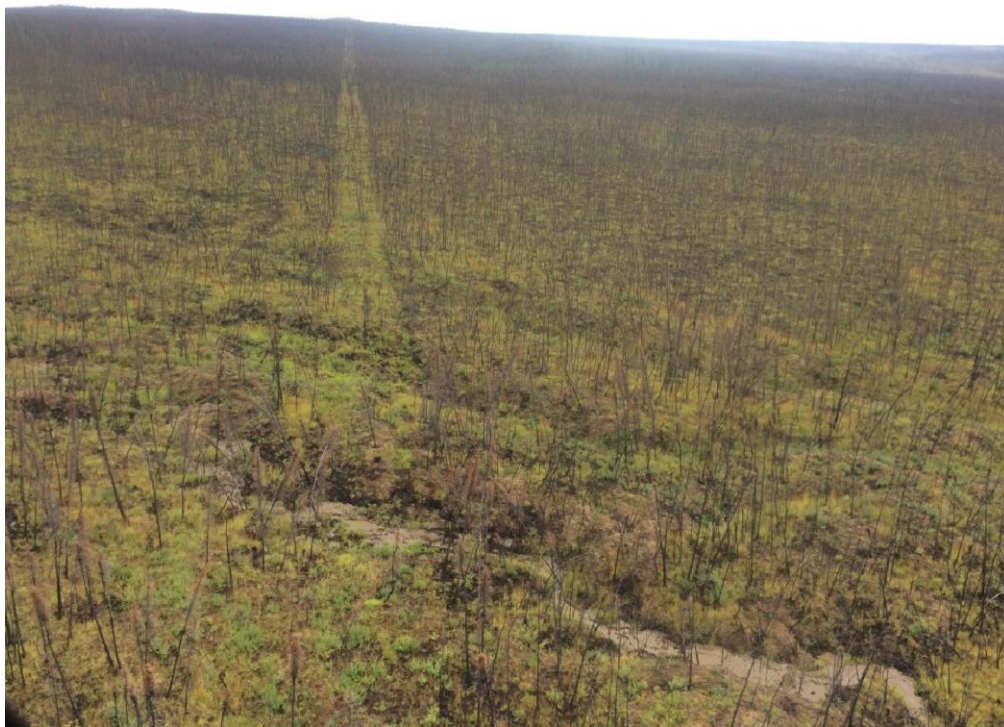
Attachment Photo A-22. Air survey plot SL228, a burnt 2D seismic line recovering at the same rate and stage as the surrounding community.

Fire had a strong effect when comparing structural stages between paired on-line and off-line plots (Figure 4-2). The top two charts in Figure 4-2 show that the pattern of structural stages for burnt areas was very similar between on-line and offline plots. The bottom two charts show that the pattern of structural stages differs substantially between on-line and offline plots in unburnt areas. In unburnt areas, off-line plots had much lower numbers of sites in Low Shrub and much higher numbers of sites in Young Forest and Mature Forest than on-line plots. For burnt areas, the on-line and off-line plots at the same site were the same structural stage in 72% of cases, and within one structural stage of each other 91% of the time (e.g., Tall Shrub vs Pole Sapling). For areas that were not burnt, the on-line and off-line plots at the same site were the same structural stage in only 29% of cases. These results demonstrate that in the absence of fire, pronounced differences between linear disturbances and the surrounding community are evident in both recent (3D) and legacy (2D and winter road) linear feature types. But following a fire, the vegetation structure on-line and off-line are likely to be similar (Photos A-22 to A-24 in Attachment A).

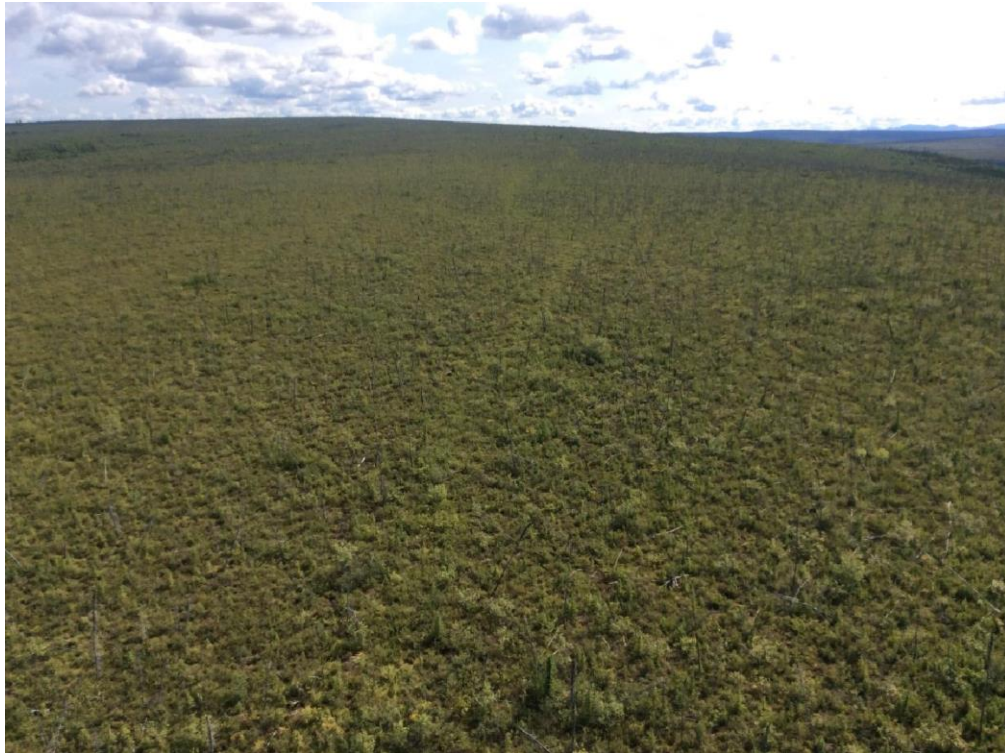
Attachment Photo A-23. Air survey plot SL326, a burnt winter road recovering at the same rate and stage as the surrounding community.

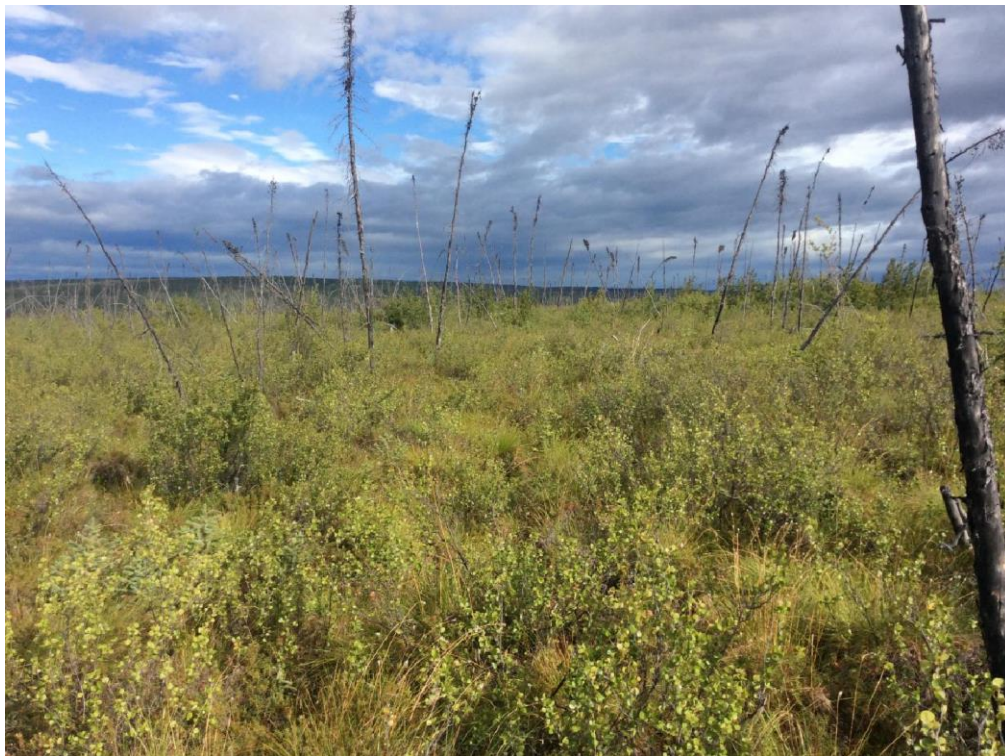
Attachment Photo A-24. Ground survey plot SL287, a burnt 3Dr seismic line recovering at the same rate and stage as the surrounding community.

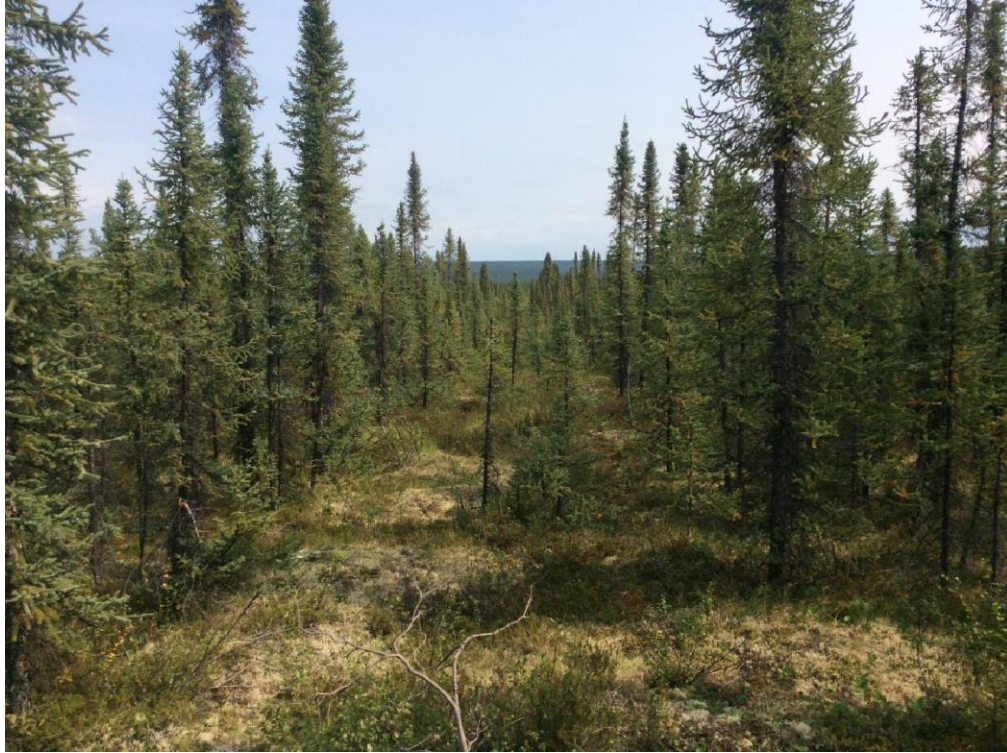
Attachment Photo A-25. Ground survey plot SL216, a feature with regenerating trees over 1.5 m tall but very sparse, illustrating one of the limitations of the NYLUP and PWRLUP functional recovery threshold.
